# Reserve Study Level I

Prepared for South Cove

2025 Fiscal Year

Prepared by CEDCORE, LLC

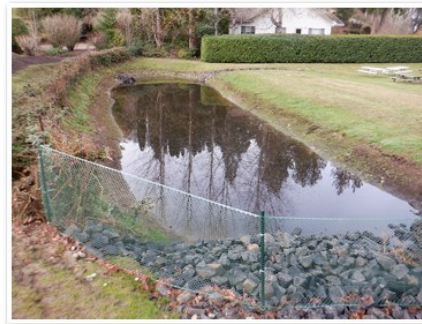
**Site/Grounds - 24" Drainage Line: Inspection**

Location: Underground Between Lot 37 and the Retention Pond  
 Current Cost:  
 Condition: Functional  
 Funding Basis: Unfunded due to unpredictable nature of component

It was reported to Cedcore that this was camera inspected by the County/City in mid December 2024 and found to be in acceptable condition. Remind County/City to reinspect in 2029 and thereafter on a 5 year cycle.

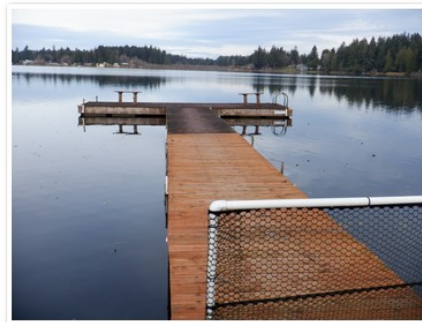
**Recreation - Dock Surface: Repair**

Location: Pattison Lake  
 Quantity: 750 Square Feet  
 UL: 1  
 RUL: 0  
 Current Cost: \$500  
 Condition: Fair  
 Funding Basis: Funded based on Association direction

Board plans to inspect and repair annually.

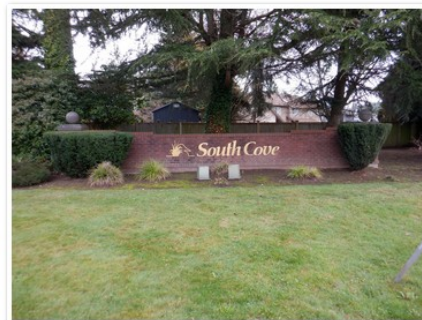
**Site/Grounds - Entry Monument: Repair/Replace**

Location: Entry  
 Quantity: 3 Each  
 Current Cost:  
 Condition: Good  
 Funding Basis: Unfunded, outside the 30 year scope of report

Good condition with no issues at this time. Sturdy construction and materials. No expectation of large scale expenses at this time. No reserve funding required.

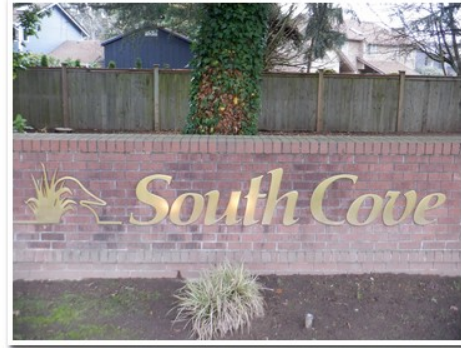
**Site/Grounds - Entry Sign: Replacement**

Location: Entrance  
 Quantity: 3 Each  
 UL: 20  
 RUL: 10  
 Current Cost: \$4,500  
 Condition: Good  
 Funding Basis: Funded based on the typical life expectancy

These appear to be prefinished metal but may need to be repainted.

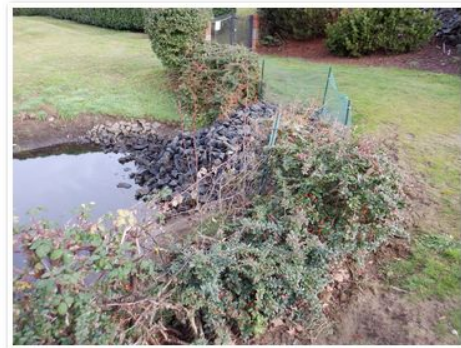
**Site/Grounds - Fence: Chainlink, Replace**

Location: Wet Retention Pond in Tract B  
 Quantity: 216 Linear Feet  
 UL: 40  
 RUL: 0  
 Current Cost: \$7,560  
 Condition: Not Applicable  
 Funding Basis: Funded based on the typical life expectancy

Safety around the retention pond relies on an old welded wire mesh fence and vegetation that has thorns on it. We recommend that the Association get written confirmation from their Insurance Provider that they are comfortable with this method of prevention of accidents at the Retention Pond.

We recommend that a 6' high chain link fence be installed around the storm water retention pond to prevent unauthorized access and accidental injury or drowning and reduce the Association's liability against potential claims.

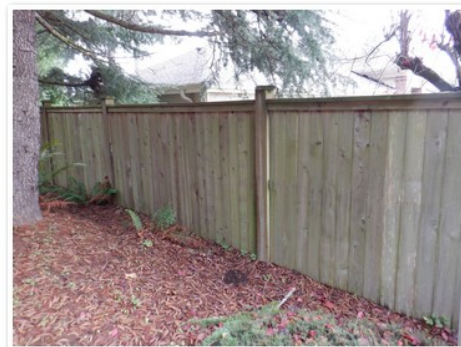
**Site/Grounds - Fence: Wood, 6', Replace**

Location: South and West perimeter  
 Quantity: 2035 Linear Feet  
 UL: 20  
 RUL: 10  
 Current Cost: \$99,700  
 Condition: Fair  
 Funding Basis: Funded based on the typical life expectancy

Good condition of wood fencing with no unusual deterioration. We understand that all old 4" x 4" Pressure Treated posts were replaced in 2016 with 6" x 6" Pressure Treated Posts. Reportedly the community inspects and repairs regularly utilizing the operating budget. Remove any contact with the ground and overgrowth to minimize advanced deterioration. We suggest continuing to seal for appearance and protection of fencing. Reserve funding is provided for the replacement at approximately the 20 year mark of life.

We also understand that the Board is considering transferring responsibility for maintenance, repair or replacement to the 13 Lot Owners that have this fence as their rear yard boundary. We recommend that the Board consult with a lawyer familiar with HOA legislation and regulations to confirm what the parameters and conditions would need to be included for this transfer to be done legally.

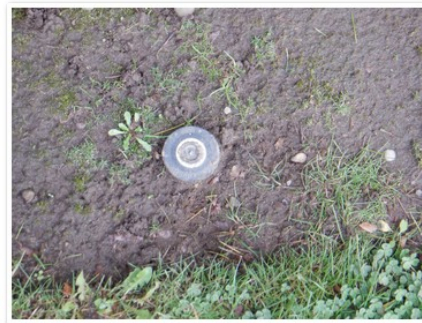
**Site/Grounds - Irrigation System: Repair/Replace**

Condition: Unknown

Unknown condition but with no reported problems at this time. We suggest including irrigation maintenance within the Association's annual landscape budget/contract, such as select sprinkler head replacements. As the community and irrigation lines age, local areas of line replacement may be needed and generally is not covered by the landscape contract. At this time there is no expectation of total line replacement, however, we have included an allowance for partial repair/replacement every few years. As these expenses occur and trends are developed update the reserve funding as needed.

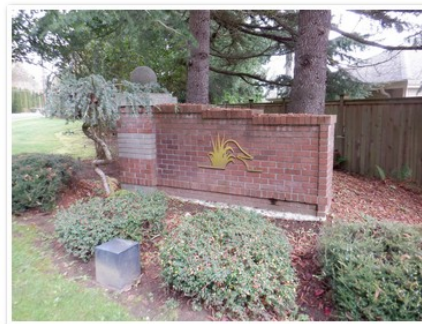
**Site/Grounds - Landscaping: Refurbish**

Condition: Assorted Condition

This component may be used to fund large landscape projects not budgeted within the Operating funds. We understand there is no desire to fund this within reserves at this time. Therefore, no reserve funding.

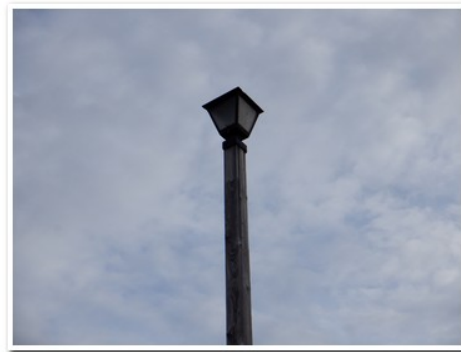
## Site/Grounds - Lights: Pole, Replace

Location: various  
 Quantity: 8 Each  
 UL: 35  
 RUL: 5  
 Current Cost: \$4,000  
 Condition: Functional  
 Funding Basis: Funded based on the typical life expectancy

We understand that the poles are owned by PSE and they invoice for replacement fixtures and bulbs.

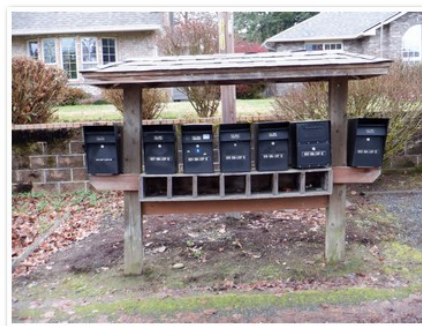
## Site/Grounds - Mailbox Locking Individual: Replace

Location: Various  
 Current Cost:  
 Condition: Assorted Condition  
 Funding Basis: Unfunded, not Association responsibility

Assorted condition of mailboxes with no unusual damage observed. Clean and repaint as needed to maintain appearance. Oil hinges to maintain ease of operation. These are Lot Owner responsibility to maintain, repair or replace.

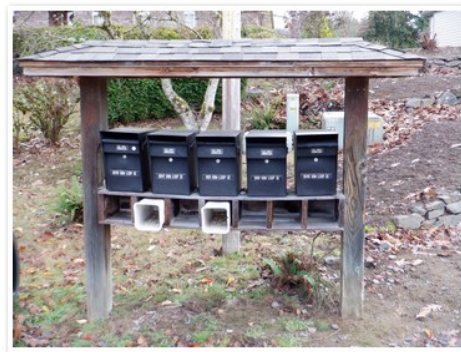
## Site/Grounds - Mailbox Structure: Repair/Replace

Location: Various  
 Quantity: 7 Each  
 UL: 35  
 RUL: 5  
 Current Cost: \$7,000  
 Condition: Functional  
 Funding Basis: Funded based on the typical life expectancy

Fair condition with no significant instability observed at this time. This structure currently does not have pressure treated lumber. Cost will vary significantly by the type of vendor and materials used. Therefore, we have factored a funding allowance, update in future reserve studies as desired.

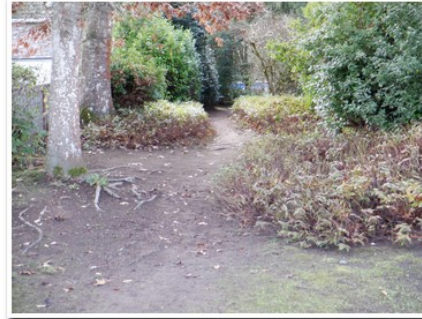
## Site/Grounds - Path: Gravel, Refurbish

Condition: Functional

Various conditions noted. We suggest including the gravel areas within the landscape contract to provide proactive maintenance. No reserve funding suggested.

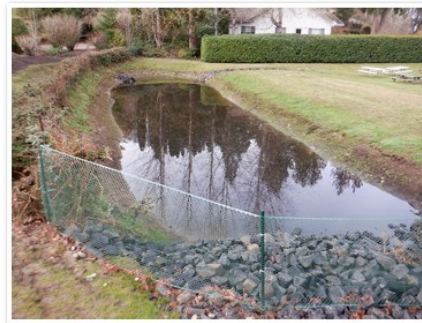
### Site/Grounds - Retention Pond

Condition: Good

Dredged in 2024. This component may be used to include funding for cycles of anticipated pond refurbishment. At this time we strongly recommend working with a qualified engineer or stormwater official to develop a operations and maintenance plan. With regular proactive maintenance there is little expectation of large expenses. However, if not maintained may include removing sediment, rebuilding the retention pond, clearing clogged inlets/outlets, correcting inadequate erosion control, etc.

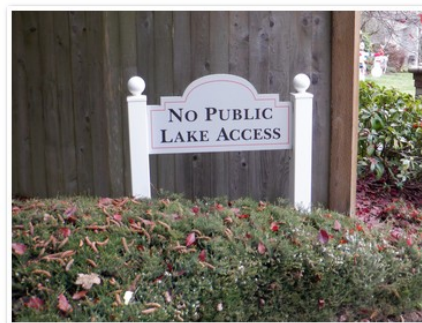
### Site/Grounds - Signs: Replace

Condition: Good

Good condition with no damage or concerns at this time. We understand there is no expectation to replace at one time, therefore, no reserve funding. Treat as a maintenance item.

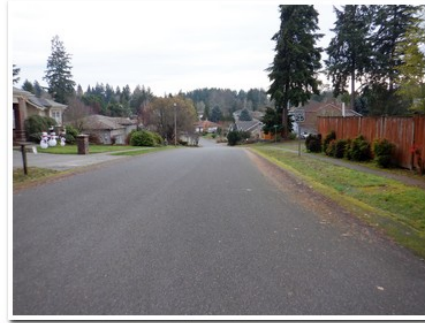
### Site/Grounds - Streets

Condition: Good

Thurston County responsibility.
